## Technical Bulletin

REMA TIP TOP Repair Recommendations for Yokohama  
“dB decibel - super E-spec” tire with AIRTEX liners.  
(2 piece repair process)

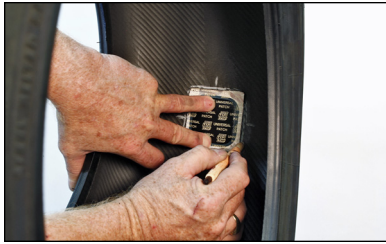
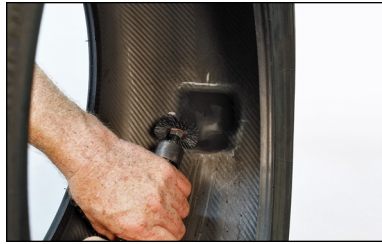
#### 2" 120 Grit Slap Action Brush

The Grit is built into the length of the bristles and not the tip. The innerliner is buffed by the whole length of the brush bristles.

6. Use the special plastic brush on a slow speed buffer (<5,000rpm) to gently remove the innerliner exposing the casing rubber underneath. **"AVOID"** buffing too deep into the casing rubber damaging the body plies of the tire. If the body plies are damaged, the tire is un-repairable. The innerliner is very thin and the brush must be moved with the hands from side to side and up and down to avoid going too deep. The innerliner is removed without pressure on the tool. Feathering the sides of the buff is necessary to avoid innerliner separation from the casing rubber. Once the innerliner is removed, continue the brushing/buffing process, until a black velvet texture is achieved on the casing rubber. The buff texture achieved with the brush appears slightly different than that of a buffing rasp, but provides a good foundation for an optimum adhesion onto the casing rubber. **An attempt to use a conventional type buffing rasp will result in body ply damage to the tire, rendering the tire un-repairable.**

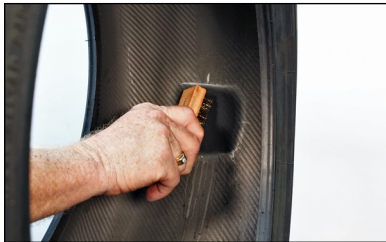
7. Clean the buff particles from the buffed texture with a brass brush and vacuum the debris from the tire

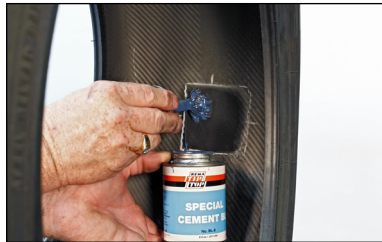
8. Apply the appropriate cement and allow to dry.

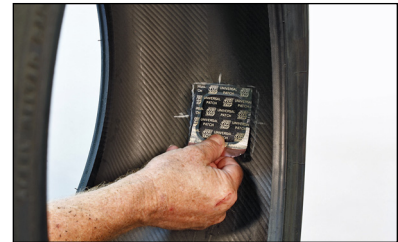
9. Install the Repair Unit.

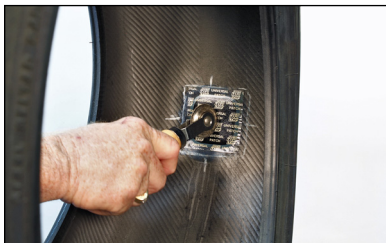
10. Stitch from the center out to remove any air and remove the poly from the top of the Repair Unit.

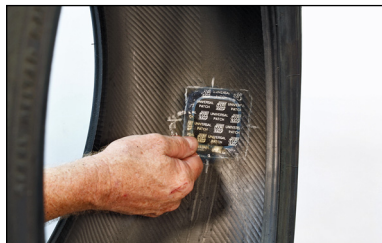
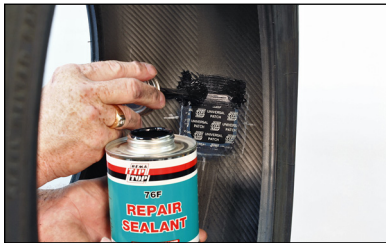
11. Repair Sealant **MUST** be applied to the whole area that the liner is removed and the repair unit does not cover.
